POSSIBLE CONSEQUENCES OF IODINE EFFECT ON REVERSE OSMOSIS MEMBRANES AND SOLUTION TO REMEDIATE AND PREVENT THEM

Authors: Alvaro Lagartos (Senior Application Engineer, LG Chem, alagartos@lgchem.com), Raul Santos (Senior Technical Engineer, LG Chem, rsantos@lgchem.com), Y.S. Son (CJ Plant Technology Team Leader, LG Chem, seannel@lgchem.com), S. Lee (Product Engineer, LG Chem, sunyounglee@lgchem.com), Y. Maeda (Asia Pacific Technical Leader, LG Chem, jmaeda@lgchem.com), J.S. Park PhD (BW TFF Leader, LG Chem, waterpark@lgchem.com)

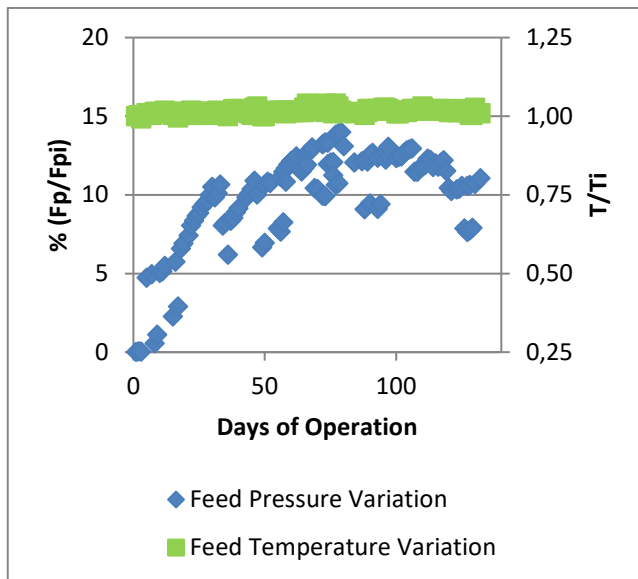
Performance of the installed membranes was monitored from the start up. After the start up, a continuous and rapid loss of performance was detected. Feed pressure rose significantly, and the salt passage decreased. The following trends were observed (Figures 1-3):

Figure 1 % Feed pressure and temperature variation increase from the start up

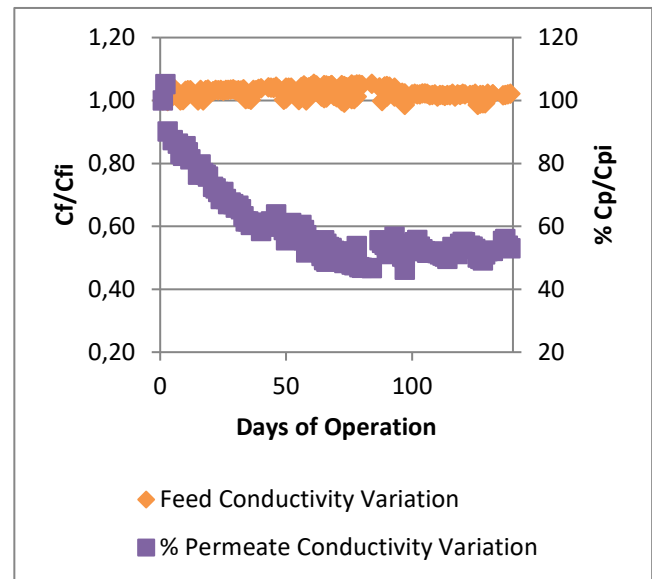
Figure 2 % Feed conductivity and permeate conductivity variation from start up

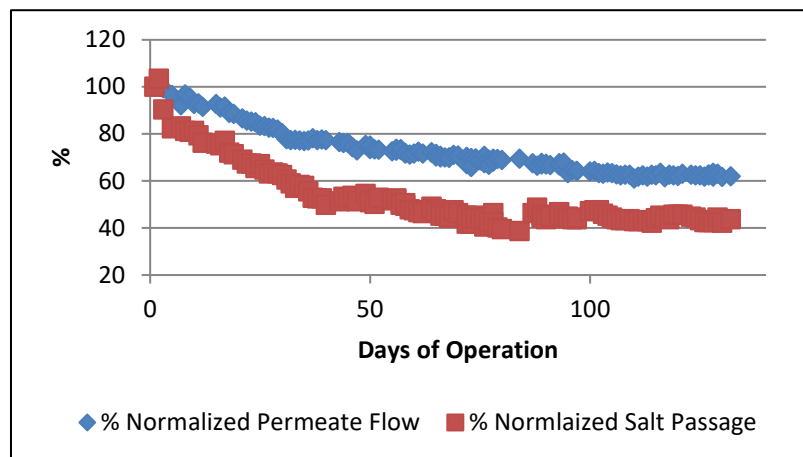
Figure 3 % Normalized Permeate Flow and Salta Passage trend from start up

Figure 3 shows a significant decrease in the normalized permeate flowrate that reached 40% after three months of operation. On the other hand, the normalized salt passage declined too (up to 60%) thus improving the rejection performance of the membranes.

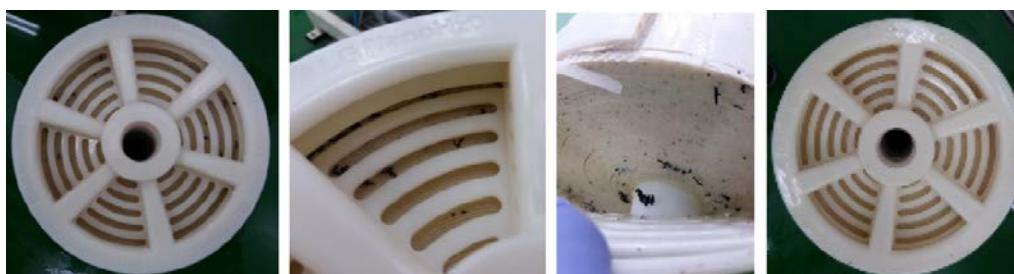
The elements were physically and visually inspected. They were in good conditions and fairly clean. Only little debris was found in the front element.

Figure 4 Autopsied membranes: external inspection

The inspection showed that the surface was clean, and no signs of severe fouling were observed. No channeling towards the feed and brine sides was detected.

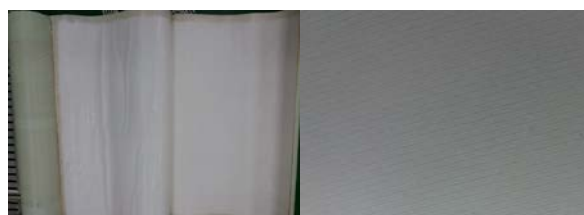
Figure 5 Autopsied membranes: membrane surface

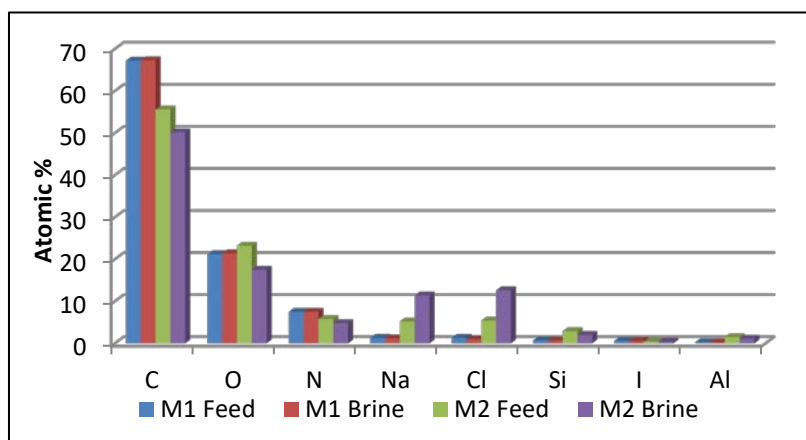
Figure 6 Individual elements results as atomic %

The results obtained from the analysis revealed small amounts of iodine (0.4 to 0.6 atomic %) on the membrane surface in conjunction with other elements such as silica and aluminum. The presence of silica and aluminum fouling was minor and therefore, not related to the membrane loss of performance.

However, iodine compounds used for disinfection had been previously reported to cause flux losses. It has been detected from the seawater membranes associated to flow decline. In addition, dissolved organic iodine is found in coastal waters and well waters. At that point it was speculated that iodine in the form of iodine-binding to polyamide layer and/or dissolved organic iodine could be responsible for these detrimental effects.

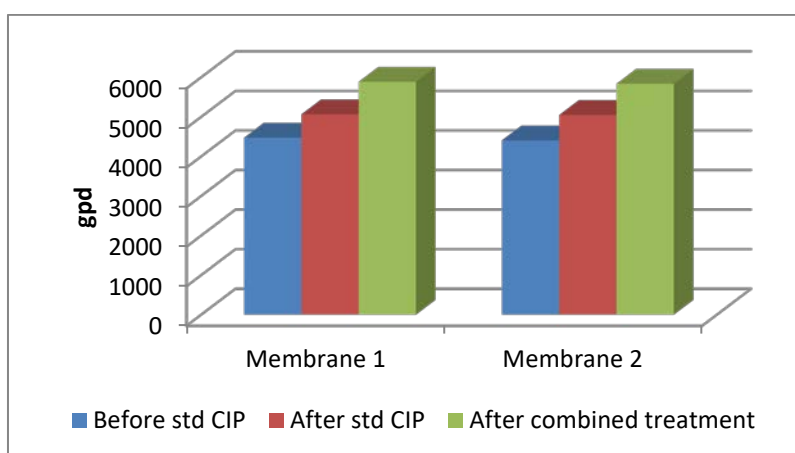
Figure 7 CIP/Combined treatment membrane element test results

The membrane performance recovery increased from 14% for standard CIP to 32% after the combined treatment.

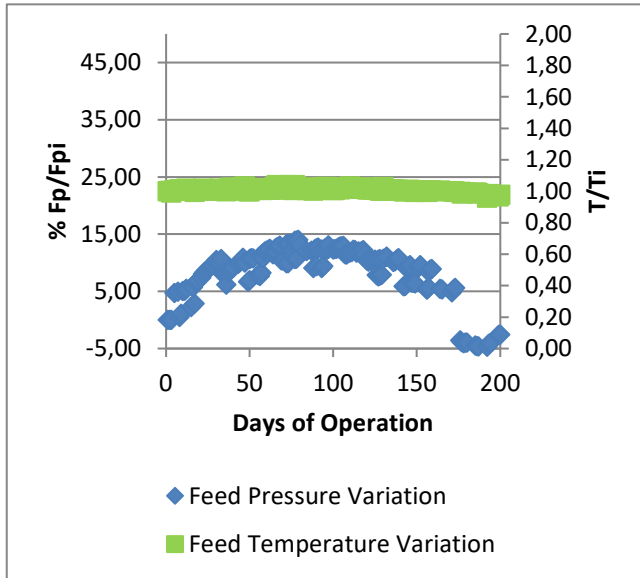
Figure 8 % Feed pressure and temperature variation increase from the start up to after post treatment

After experiments performed at LG Chem research facilities, the membranes installed on site were treated by a combined treatment using standard CIP and oxidative cleaning.

The combined cleaning was performed between days 173 and 176 of operation.

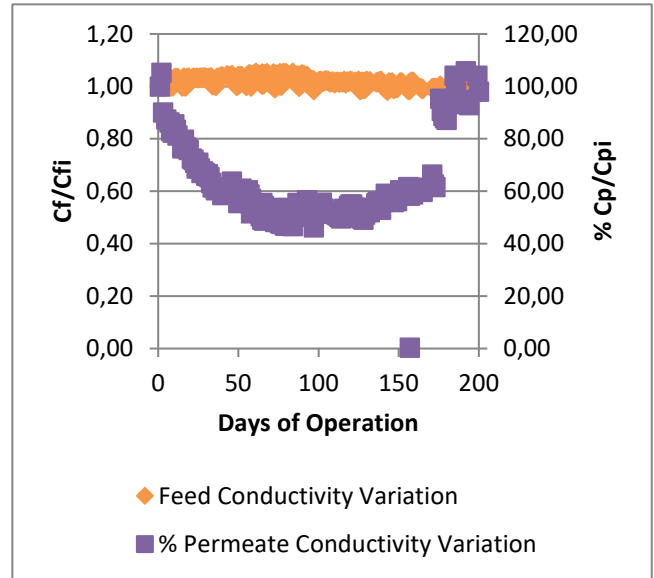
Figure 9 % Feed conductivity and permeate conductivity variation from start up to after post treatment

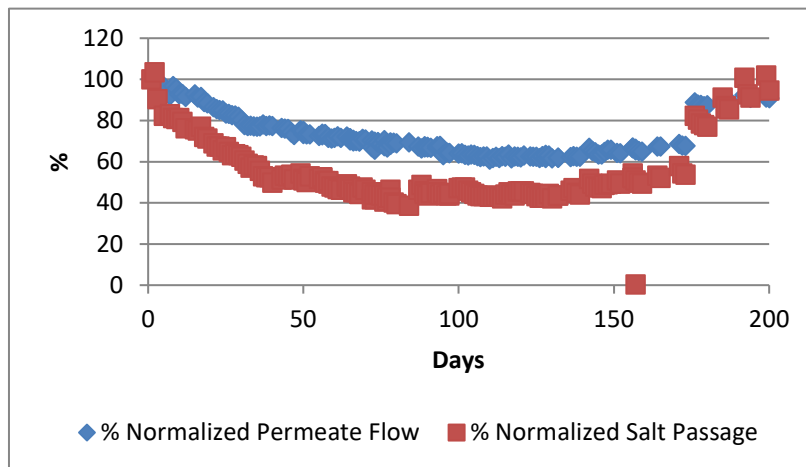
Figure 10 % Normalized Permeate Flow and Salta Passage trend from start up to after post treatment

As it can be observed from the above graphs, the results obtained on the site were quite successful. Normalized permeate flow was recovered up to 30% and normalized salt passage was increased by 50% achieving values very close to the start-up values.
